AROUND THE GRAVES

NEWSLETTER OF THE FRIENDS OF CHELTENHAM AND REGIONAL CEMETERIES INC.

Caulfield Railway Disaster Biographical Register

26-5-26: Carnage and Courage at Caulfield

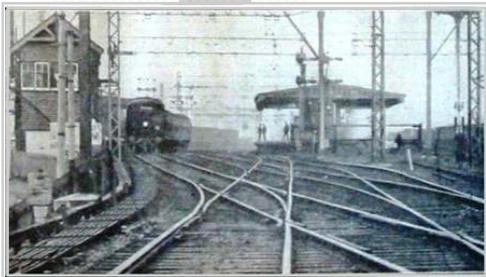
Caulfield Railway Station showing signal box 'A'. A train can be seen at platform 4

Unlike the other three platforms at the Caulfield Railway Station, a train travelling along the local line had an obscured view of platform 4 due to an idiosyncratic feature on the up side. The location of

signal box 'A' stood 70 feet from the end of the platform where there was a sharp bend in the track leading to platform 4. Unable to see the presence of any traffic until

after passing the home signal, the driver of an approaching train had to rely solely on semaphore (post) 1 giving the all-clear to proceed. With an obscured view and no trip system in place, Fate could not ask for a more ideal location to rear its ugly head.

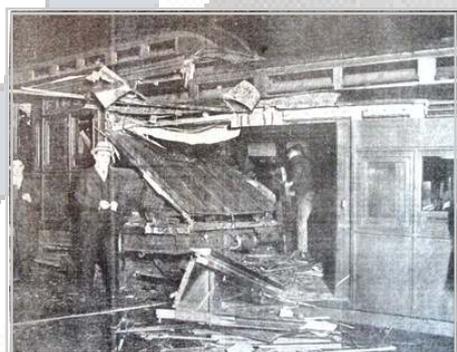
The telescoped carriages, showing the first-class trailer on the left and the second-class motorvan

When the crash came, it was as swift as it was sudden with appalling results. The frame and body of the trailer forced the motorvan to rise in the air more than a metre as the compartments crumbled like a concertina into a mass of mangled wreckage, shattering glass and splitting woodwork. When the pantographs went out, the carriages were sent into sudden darkness as the trapped and helpless passengers tried desperately to free themselves.

The luckiest person to escape the impact was the driver of the Oakleigh train, William Stevenson Milvain. Structurally, the cabin of the front motorvan withstood the shock and suffered only minor damage, and Milvain was not badly hurt, but he was flung against the side of the cabin, and suffered severely from shock. He may have had a lucky escape, but the worst was yet to come. Life would never be the same for the veteran with an impeccable 13-year record as an engine driver.
